Voss Clark - Defect Image - Original

Coil No.: 084220 (206494)	Printed: 12/15/2010 17:06
Inspected: 12/11/2010 03:20 - 12/11/2010 03:31	Inspection Location: Pickle

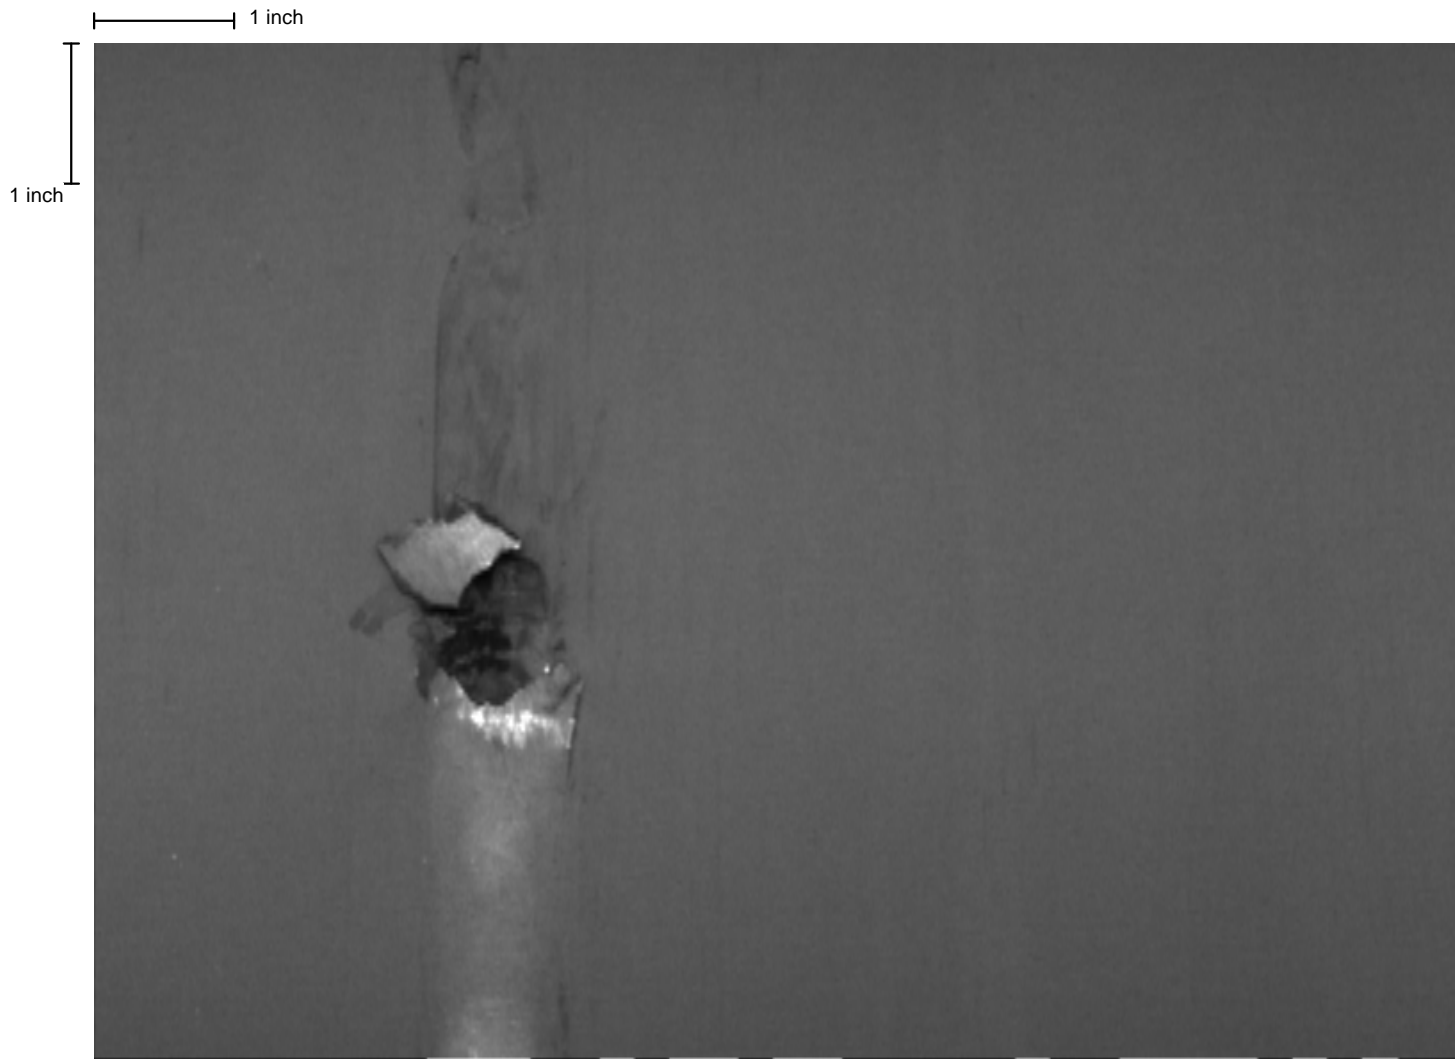
\\CAMERA-PC01\images\00206494\04\P651003_00206494_04_srcimg_0429.tif

Defect Description	
Defect ID	8906
Class	LAO
Prod. Class / Test Class	NC / NC
Grade	---
Confidence	100 %
Dist. from DS	13.66 in
Dist. from OS	36.38 in
Distance from start	2145 ft 5.8 in
Width	1.890 in
Length	7.165 in
Period length	53.03 in
Period Id	21
Camera	4
Image ID	429
Coil Side	Bottom Side BF
Roll	-----
